**Flood Control Project Maintenance  
Levee Inspections**

## Maintenance Issue Types Only, Levee Inspection Report By Mile - Spring 2019

### Lake County Watershed Protection District

Waterway	Bank	Unit Miles	Inspection Start/End	Inspector
Unit No. 01 Middle Creek	Left	3.35	04/11/2019 05/24/2019	Luz Dial

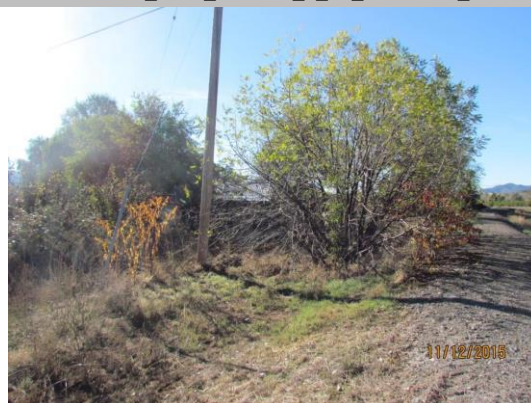
Photo 1 of 1 : SP\_2019\_NA0009\_3\_11\_20190411\_00006.jpg

View of the overgrown trees at the landside slope.

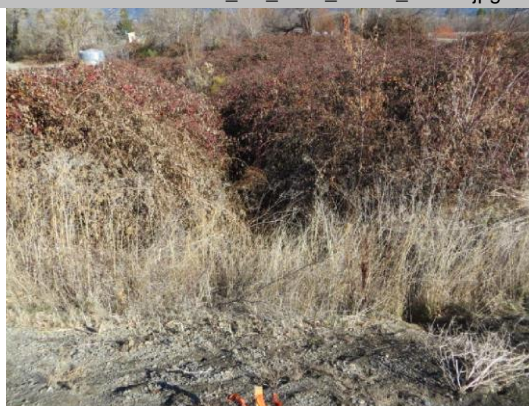
Photo 1 of 3 : UCIP\_SP\_2019\_26987\_49853.jpg

LM Start	2.26	Rating **	A/W	Issue No.	537
LM End	2.26	Issue Type +	Ma	Location *	
Category	Supplemental			GPS Latitude/Longitude	
				Start	End
Item	DWR UCIP LMA Responsibility			39.160327 °	39.160327 °
				-122.913998 °	-122.913998 °
DWR ID	21240				
Comment Code					
Inspector Comment					
FS_ID:26987 DS_ID:21240 EP_NO: N/A Repair Type: No Action Needed Crossing Status: Found UCIP Comments: FIELD_STRUCT_DESC: 2 of 2: 36-inch corrugated metal drainage pipe through the levee, 9 feet below the crown. Flap gate on the waterside (WS) end. Concrete headwalls on both ends. (two 36-inch pipes [HLM 2.26] retained under Automatic Board Order (ABO) issued as Permit No. 11460, 1975 - Robert L. and Lavona Gentry). [Additional Reference(s): DWR Levee Log, 2005. USACE Sacramento O&M Manual 506.2, August 1961, (HLM 2.26)]. FS Date: 1/14/2014

Pipe and Concrete headwall visible on LS toe.

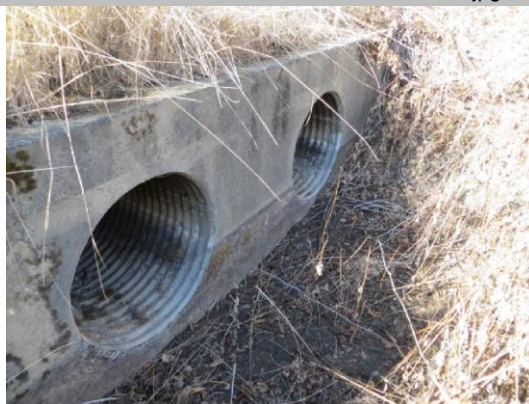
Photo 2 of 3 : UCIP\_SP\_2019\_26987\_49852.jpg

Pipe and Concrete headwall visible on LS toe.

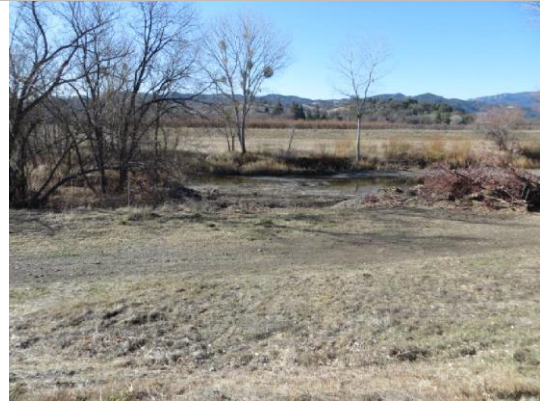
Photo 3 of 3 : UCIP\_SP\_2019\_26987\_49851.jpg

LM Start	2.26	Rating **	A/W	Issue No.	537 (cont)
LM End	2.26	Issue Type +	Ma	Location *	
Category	Supplemental			GPS Latitude/Longitude	
				Start	End
Item	DWR UCIP LMA Responsibility			39.160327 °	39.160327 °
				-122.913998 °	-122.913998 °
DWR ID	21240				
Comment Code					
Inspector Comment					
FS_ID:26987 DS_ID:21240 EP_NO: N/A Repair Type: No Action Needed Crossing Status: Found UCIP Comments: FIELD_STRUCT_DESC: 2 of 2: 36-inch corrugated metal drainage pipe through the levee, 9 feet below the crown. Flap gate on the waterside (WS) end. Concrete headwalls on both ends. (two 36-inch pipes [HLM 2.26] retained under Automatic Board Order (ABO) issued as Permit No. 11460, 1975 - Robert L. and Lavona Gentry). [Additional Reference(s): DWR Levee Log, 2005. USACE Sacramento O&M Manual 506.2, August 1961, (HLM 2.26)]. FS Date: 1/14/2014

Pipe, Concrete headwall, and flap gate visible on WS berm.

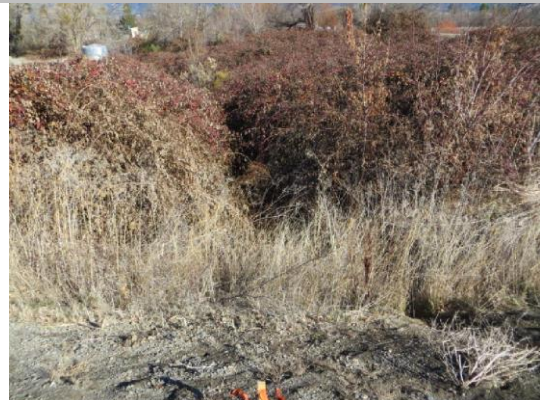
Photo 1 of 3 : UCIP\_SP\_2019\_26986\_49849.jpg

LM Start	2.26	Rating **	A/W	Issue No.	538
LM End	2.26	Issue Type +	Ma	Location *	
Category	Supplemental			GPS Latitude/Longitude	
				Start	End
Item	DWR UCIP LMA Responsibility			39.160272 °	39.160272 °
				-122.913966 °	-122.913966 °
DWR ID	21197				
Comment Code					
Inspector Comment					
FS_ID:26986 DS_ID:21197 EP_NO: N/A Repair Type: No Action Needed Crossing Status: Found UCIP Comments: FIELD_STRUCT_DESC: 1 of 2: 36-inch corrugated metal drainage pipe through the levee, 9 feet below the crown. Flap gate on the waterside (WS) end. Concrete U-shaped headwalls on both ends. (two 36-inch pipes [HLM 2.26] retained under Automatic Board Order (ABO) issued as Permit No. 11460, 1975 - Robert L. and Lavona Gentry). [Additional Reference(s): DWR Levee Log, 2005. USACE Sacramento O&M Manual 506.2, August 1961, (HLM 2.26)]. FS Date: 1/9/2014

Concrete headwall and pipe visible on LS toe at end of drainage swale.

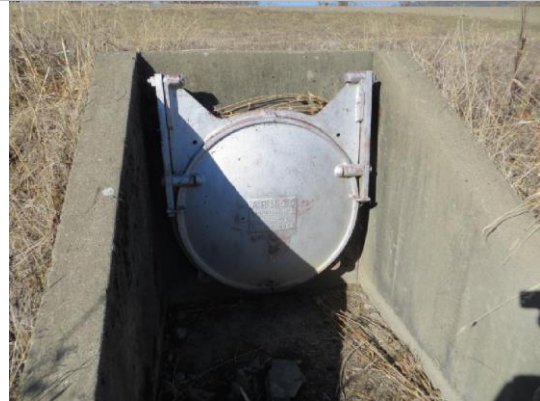
Photo 3 of 3 : UCIP\_SP\_2019\_27004\_49860.jpg

LM Start	2.35	Rating **	M	Issue No.	539 (cont)	
LM End	2.35	Issue Type +	Ma	Location *		
Category	Supplemental			GPS Latitude/Longitude		
				Start	End	
Item	DWR UCIP LMA Responsibility			39.161002 °	39.161002 °	
				-122.912843 °	-122.912843 °	
DWR ID	21199					
Comment Code						
Inspector Comment						
FS_ID:27004 DS_ID:21199 EP_NO: 11460 Repair Type: Non-Urgent Crossing Status: Found UCIP Comments: Heavy vegetation on LS at inlet should be removed. FIELD_STRUCT_DESC: 42-inch corrugated metal drainage pipe through the levee, 10 feet below the crown. Flap gate on the waterside (WS) end. Concrete headwall on both ends. (42-inch pipe [HLM 2.35] retained under Automatic Board Order (ABO) issued as Permit No. 11460, 1975 - Robert L. and Lavona Gentry). [Additional Reference(s): DWR Levee Log, 2005. USACE Sacramento O&M Manual 506.2, August 1961, (HLM 2.35)]. FS Date: 1/14/2014

Concrete U-shaped headwall and flap gate on WS berm.

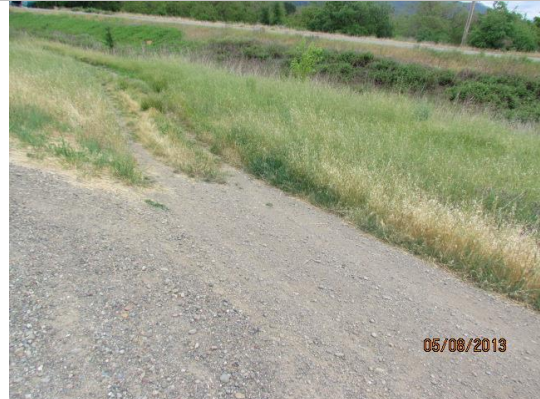
Photo 1 of 1 : SP\_2019\_NA0009\_3\_14\_20190411\_00008.jpg

LM Start	2.36	Rating **	A/W	Issue No.	14
LM End	2.36	Issue Type +	Ma	Location *	WS
Category	Earthen Levee			GPS Latitude/Longitude	
				Start	End
Item	Slope Stability			39.161153 °	39.161153 °
				-122.912740 °	-122.912740 °
DWR ID	DWR_NA0009_01_s_2013_14				
Comment Code					
S3 : Repair the levee slope damaged by vehicle traffic and prevent access where possible.					
Inspector Comment

View of the vehicle erosion along the waterside slope.

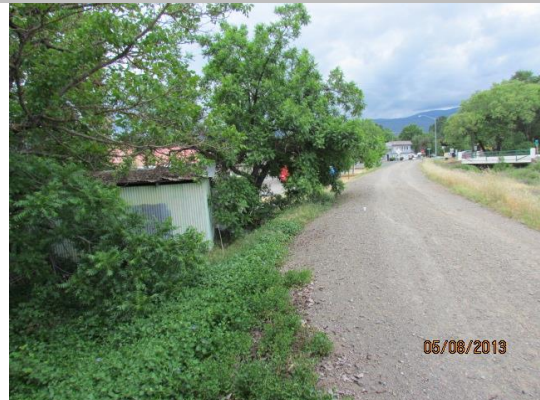
Photo 1 of 1 : SP\_2019\_NA0009\_3\_15\_20190411\_00009.jpg

LM Start	2.38	Rating **	M	Issue No.	15
LM End	2.43	Issue Type +	Ma	Location *	LS
Category	Earthen Levee			GPS Latitude/Longitude	
				Start	End
Item	Trim / Thin Trees			39.161381 °	39.161935 °
				-122.912551 °	-122.911883 °
DWR ID	DWR_NA0009_01_s_2013_15				
Comment Code					
T1 : Trim trees to at least five feet above ground level.					
Inspector Comment					
Trim the trees to at least 5 feet above the ground for visibility, and remove the vegetation from the slope.

Trim the trees up 5 feet to allow visibility.

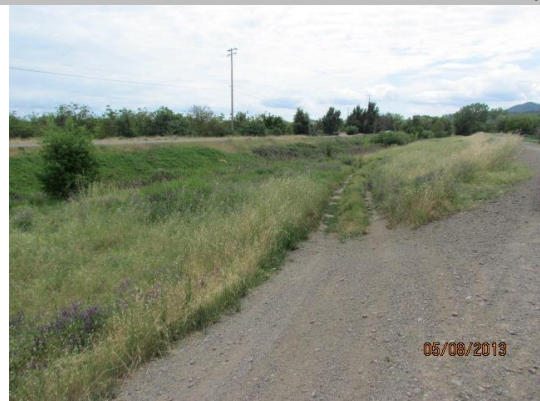
Photo 1 of 1 : SP\_2019\_NA0009\_3\_16\_20190411\_00010.jpg

LM Start	2.40	Rating **	M	Issue No.	16
LM End	2.40	Issue Type +	Ma	Location *	WS
Category	Earthen Levee			GPS Latitude/Longitude	
				Start	End
Item	Slope Stability			39.161601 °	39.161601 °
				-122.912303 °	-122.912303 °
DWR ID	DWR_NA0009_01_s_2013_16				
Comment Code					
S3 : Repair the levee slope damaged by vehicle traffic and prevent access where possible.					
Inspector Comment

View of the vehicle erosion along the waterside slope.

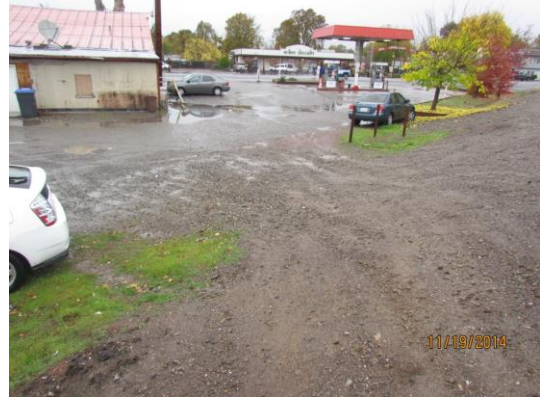
Photo 1 of 1 : SP\_2019\_NA0009\_3\_17\_20190411\_00011.jpg

LM Start	2.42	Rating **	M	Issue No.	17
LM End	2.42	Issue Type +	Ma	Location *	LS
Category	Earthen Levee			GPS Latitude/Longitude	
				Start	End
Item	Slope Stability			39.161802 °	39.161802 °
				-122.912020 °	-122.912020 °
DWR ID	DWR_NA0009_01_s_2013_17				
Comment Code					
S3 : Repair the levee slope damaged by vehicle traffic and prevent access where possible.					
Inspector Comment

View of the erosion caused by vehicle along the landside slope.

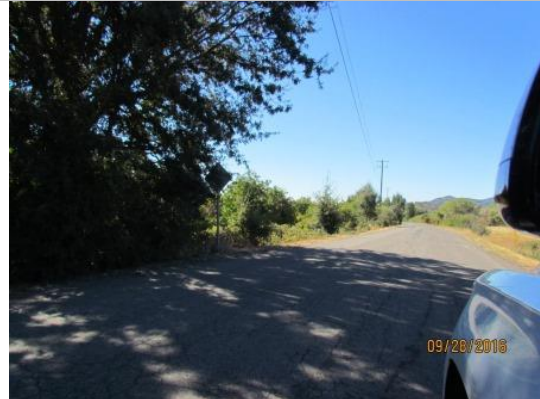
Photo 2 of 2 : SP\_2019\_NA0009\_3\_3\_20190411\_00002.jpg

LM Start	2.48	Rating **	U	Issue No.	3
LM End	2.55	Issue Type +	Ma	Location *	LS
Category	Earthen Levee			GPS Latitude/Longitude	
				Start	End
Item	Vegetation			39.161615 °	39.160804 °
				-122.911733 °	-122.912536 °
DWR ID	DWR_NA0009_01_s_2012_3				
Comment Code					
V2 : Remove the wild growth other than native grasses from the levee slopes.					
Inspector Comment					
The LMA cleared vegetation on the levee slope, but thick brush remains on the other side of the wire fence along the levee toe easement.

View of the vegetation along the landside slope.

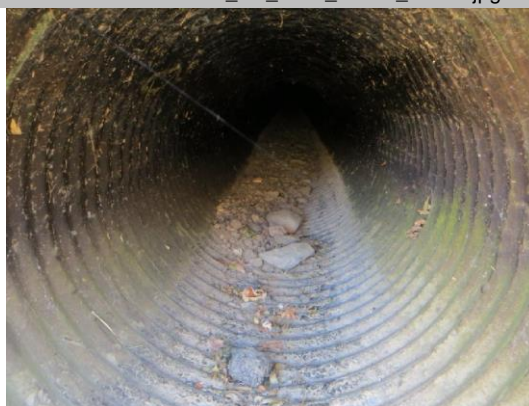
Photo 2 of 3 : UCIP\_SP\_2019\_27184\_50321.jpg

LM Start	0.24	Rating **	A/W	Issue No.	41 (cont)	
LM End	0.24	Issue Type +	Ma	Location *		
Category	Supplemental			GPS Latitude/Longitude		
				Start		End
Item	DWR UCIP LMA Responsibility			39.186794 °		39.186794 °
				-122.909413 °		-122.909413 °
DWR ID	21204					
Comment Code						
Inspector Comment						
FS_ID:27184 DS_ID:21204 EP_NO: 11484 Repair Type: No Action Needed Crossing Status: Found UCIP Comments: FIELD_STRUCT_DESC: 36-inch corrugated metal drainage pipe through the levee, 6 feet below the crown. Flap gate on the waterside (WS) end. Concrete headwalls on both ends. (36-inch pipe [HLM 0.23] retained under Automatic Board Order (ABO) issued as Permit No. 11484, 1975 - Rodney Snow). [Additional Reference(s): DWR Levee Log, 2005. USACE Sacramento O&M Manual 506.2, August 1961, (HLM 0.23)]. FS Date: 1/14/2014

Pipe at inlet.

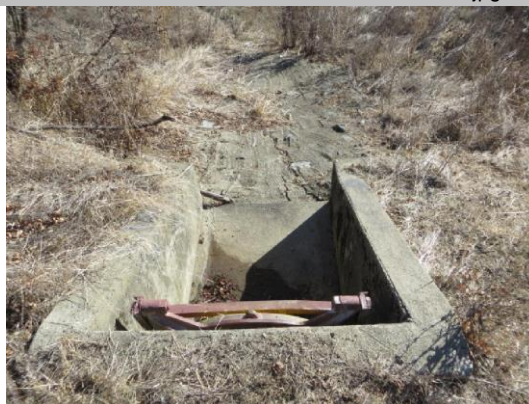
Photo 3 of 3 : UCIP\_SP\_2019\_27184\_50320.jpg

Flapgate and concrete headwall on WS toe.

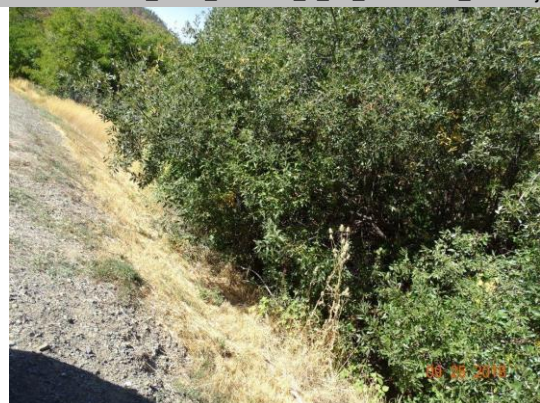
Photo 1 of 1 : SP\_2019\_NA0009\_4\_29\_20190411\_00011.jpg

View of the trees along the landside slope and toe.

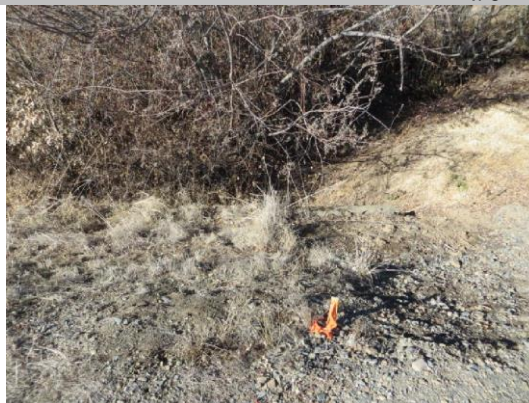
Photo 1 of 3 : UCIP\_SP\_2019\_27192\_50326.jpg

LM Start	0.39	Rating **	A/W	Issue No.	42
LM End	0.39	Issue Type +	Ma	Location *	
Category	Supplemental			GPS Latitude/Longitude	
				Start	End
Item	DWR UCIP LMA Responsibility			39.185174 °	39.185174 °
				-122.911171 °	-122.911171 °
DWR ID	21206				
Comment Code					
Inspector Comment					
FS_ID:27192 DS_ID:21206 EP_NO: 11478 Repair Type: No Action Needed Crossing Status: Found UCIP Comments: FIELD_STRUCT_DESC: 42-inch corrugated metal drainage pipe through the levee, 7.7 feet below the crown. Flap gate on the waterside (WS) end. Concrete headwalls on both ends. Grouted spillway over revetment on bank. (42-inch pipe [HLM 0.38] retained under Automatic Board Order (ABO) issued as Permit No. 11478, 1975 - William D. and Dorothy L. Allison). [Additional Reference(s): DWR Levee Log, 2005. USACE Sacramento O&M Manual 506.2, August 1961, (HLM 0.38)]. FS Date: 1/14/2014

Pipe and concrete headwall at LS toe.

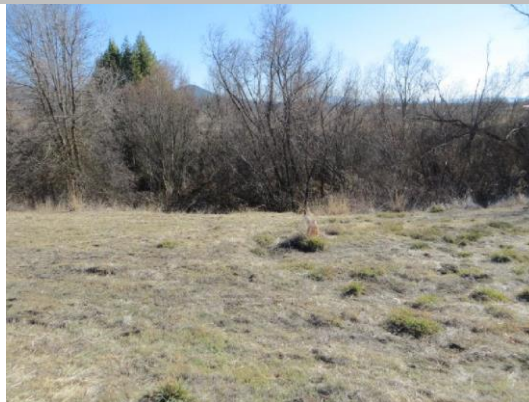
Photo 2 of 3 : UCIP\_SP\_2019\_27192\_50325.jpg

Flapgate and headwall off WS toe at berms edge.

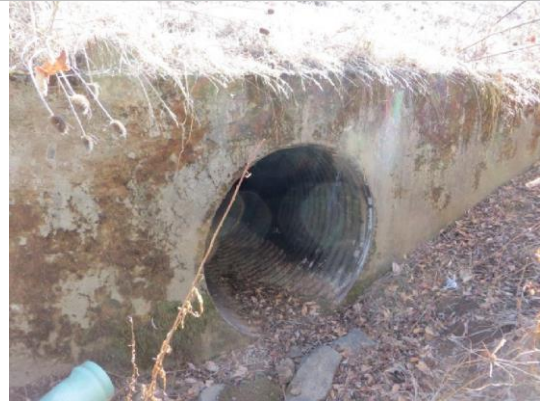
Photo 3 of 3 : UCIP\_SP\_2019\_27192\_50324.jpg

Comment Code						
Inspector Comment						
FS_ID:27192						
DS_ID:21206						
EP_NO: 11478						
Repair Type: No Action Needed						
Crossing Status: Found						
UCIP Comments:						
FIELD_STRUCT_DESC: 42-inch corrugated metal drainage pipe through the levee, 7.7 feet below the crown. Flap gate on the waterside (WS) end. Concrete headwalls on both ends. Grouted spillway over revetment on bank. (42-inch pipe [HLM 0.38] retained under Automatic Board Order (ABO) issued as Permit No. 11478, 1975 - William D. and Dorothy L. Allison). [Additional Reference(s): DWR Levee Log, 2005. USACE Sacramento O&M Manual 506.2, August 1961, (HLM 0.38)].						
FS Date: 1/14/2014

Pipe and concrete headwall at LS toe.

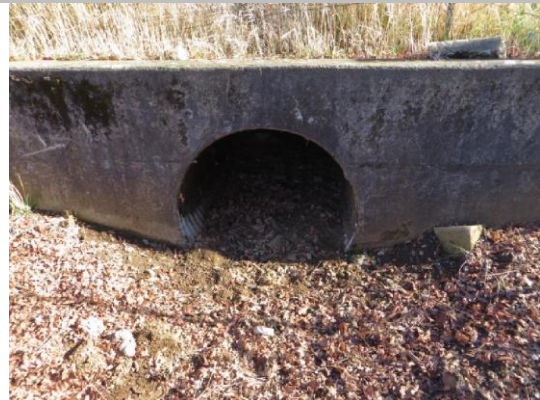
Photo 1 of 3 : UCIP\_SP\_2019\_27199\_50389.jpg

LM Start	0.48	Rating **	A/W	Issue No.	43
LM End	0.48	Issue Type +	Ma	Location *	
Category	Supplemental			GPS Latitude/Longitude	
				Start	End
Item	DWR UCIP LMA Responsibility			39.184126 °	39.184126 °
				-122.912118 °	-122.912118 °
DWR ID	21208				
Comment Code					
Inspector Comment					
FS_ID:27199 DS_ID:21208 EP_NO: 11480 Repair Type: No Action Needed Crossing Status: Found UCIP Comments: FIELD_STRUCT_DESC: 42-inch corrugated metal drainage pipe through the levee, 7 feet below the crown. Flap gate on the waterside (WS) end. Concrete headwalls on both ends. (42-inch pipe [HLM 0.47] retained under Automatic Board Order (ABO) issued as Permit No. 11480, 1975 - Jose G. and Dora Moto). [Additional Reference(s): DWR Levee Log, 2005. USACE Sacramento O&M Manual 506.2, August 1961, (HLM 0.47)]. FS Date: 1/14/2014

Concrete headwall on LS toe.

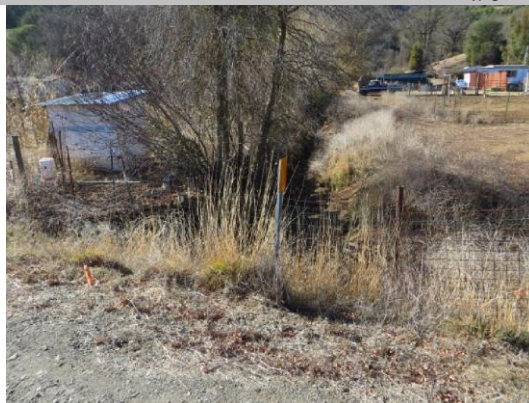
Photo 2 of 3 : UCIP\_SP\_2019\_27199\_50388.jpg

LM Start	0.48	Rating **	A/W	Issue No.	43 (cont)	
LM End	0.48	Issue Type +	Ma	Location *		
Category	Supplemental			GPS Latitude/Longitude		
				Start		End
Item	DWR UCIP LMA Responsibility			39.184126 °		39.184126 °
				-122.912118 °		-122.912118 °
DWR ID	21208					
Comment Code						
Inspector Comment						
FS_ID:27199 DS_ID:21208 EP_NO: 11480 Repair Type: No Action Needed Crossing Status: Found UCIP Comments: FIELD_STRUCT_DESC: 42-inch corrugated metal drainage pipe through the levee, 7 feet below the crown. Flap gate on the waterside (WS) end. Concrete headwalls on both ends. (42-inch pipe [HLM 0.47] retained under Automatic Board Order (ABO) issued as Permit No. 11480, 1975 - Jose G. and Dora Moto). [Additional Reference(s): DWR Levee Log, 2005. USACE Sacramento O&M Manual 506.2, August 1961, (HLM 0.47)]. FS Date: 1/14/2014

Pipe and concrete headwall on LS toe.

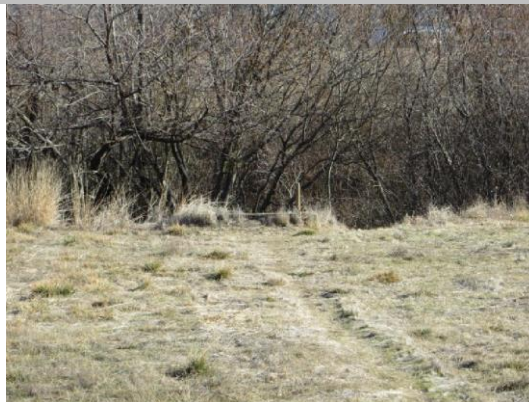
Photo 3 of 3 : UCIP\_SP\_2019\_27199\_50387.jpg

Concrete headwall and flapgate visible on waterside berm

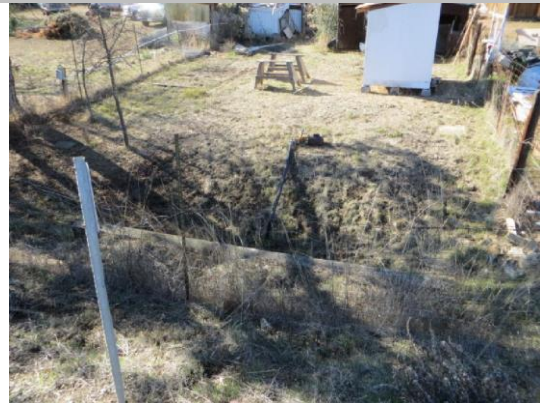
Photo 1 of 3 : UCIP\_SP\_2019\_27208\_50411.jpg

LM Start	0.55	Rating **	M	Issue No.	46
LM End	0.55	Issue Type +	Ma	Location *	
Category	Supplemental			GPS Latitude/Longitude	
				Start	End
Item	DWR UCIP LMA Responsibility			39.183130 °	39.183130 °
				-122.912198 °	-122.912198 °
DWR ID	21210				
Comment Code					
Inspector Comment					
FS_ID:27208 DS_ID:21210 EP_NO: 11482 Repair Type: Non-Urgent Crossing Status: Found UCIP Comments: Fence on LS slope creates access issue. FIELD_STRUCT_DESC: 36-inch corrugated metal drainage pipe through the levee, 9 feet below the crown. Flap gate on the waterside (WS) end. Concrete headwalls on both ends. (36-inch pipe [HLM 0.54] retained under ABO No. 11482, 1975 - George R. and Gladys Schneider). [Additional Reference(s): DWR Levee Log, 2005. USACE Sacramento O&M Manual 506.2, August 1961, (HLM 0.54)]. FS Date: 1/14/2014

Concrete headwall on LS toe.

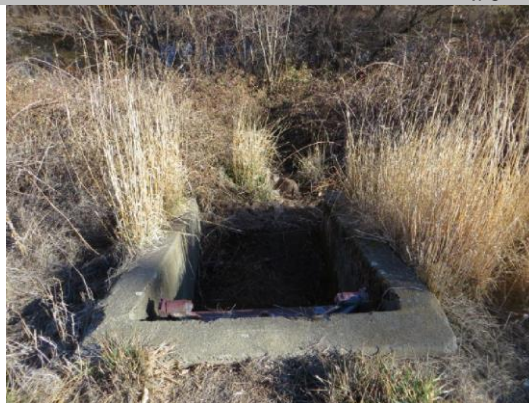
Photo 2 of 3 : UCIP\_SP\_2019\_27208\_50410.jpg

LM Start	0.55	Rating **	M	Issue No.	46 (cont)	
LM End	0.55	Issue Type +	Ma	Location *		
Category	Supplemental			GPS Latitude/Longitude		
				Start	End	
Item	DWR UCIP LMA Responsibility			39.183130 °	39.183130 °	
				-122.912198 °	-122.912198 °	
DWR ID	21210					
Comment Code						
Inspector Comment						
FS_ID:27208 DS_ID:21210 EP_NO: 11482 Repair Type: Non-Urgent Crossing Status: Found UCIP Comments: Fence on LS slope creates access issue. FIELD_STRUCT_DESC: 36-inch corrugated metal drainage pipe through the levee, 9 feet below the crown. Flap gate on the waterside (WS) end. Concrete headwalls on both ends. (36-inch pipe [HLM 0.54] retained under ABO No. 11482, 1975 - George R. and Gladys Schneider). [Additional Reference(s): DWR Levee Log, 2005. USACE Sacramento O&M Manual 506.2, August 1961, (HLM 0.54)]. FS Date: 1/14/2014

Flapgate and concrete headwall on WS berm.

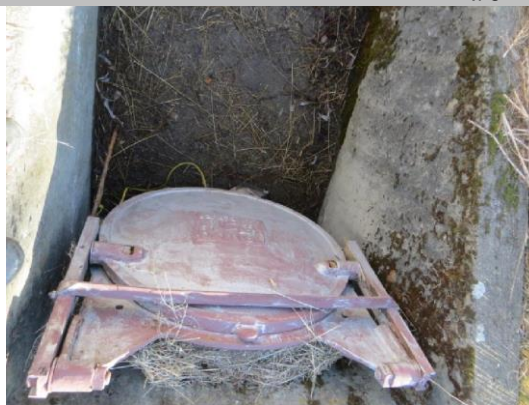
Photo 3 of 3 : UCIP\_SP\_2019\_27208\_50409.jpg

Flapgate and concrete headwall on WS berm.

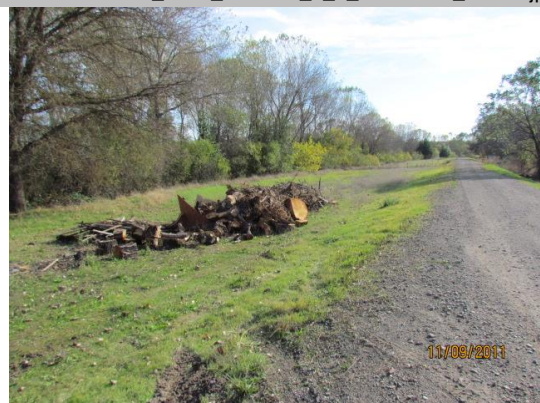
Photo 1 of 1 : SP\_2019\_NA0009\_4\_3\_20190411\_00003.jpg

View of the tree prunings on the W/S toe.

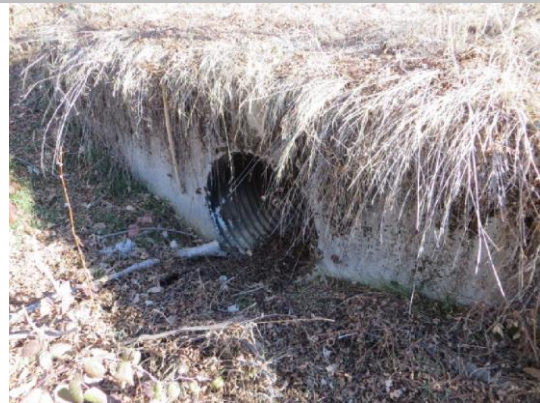
Photo 1 of 3 : UCIP\_SP\_2019\_27583\_51202.jpg

LM Start	1.03	Rating **	A/W	Issue No.	47	
LM End	1.03	Issue Type +	Ma	Location *		
Category	Supplemental			GPS Latitude/Longitude		
				Start		End
Item	DWR UCIP LMA Responsibility			39.176366 °		39.176366 °
				-122.913509 °		-122.913509 °
DWR ID	21211					
Comment Code						
Inspector Comment						
FS_ID:27583 DS_ID:21211 EP_NO: 11486 Repair Type: No Action Needed Crossing Status: Found UCIP Comments: FIELD_STRUCT_DESC: 36-inch corrugated metal drainage pipe through the levee, 7.3 feet below the crown. Flap gate on the waterside (WS) end. Concrete headwalls on both ends. Splash apron broken off on the WS end. (36-inch pipe [HLM 1.08] retained under Automatic Board Order (ABO) issued as Permit No. 11486, 1975 - Mary Truesdell). [Additional Reference(s): DWR Levee Log, 2005. USACE Sacramento O&M Manual 506.2, August 1961, (HLM 1.08) Drawing No. CC-4-4-29]. FS Date: 1/22/2014

Pipe visible at concrete inlet on LS toe.

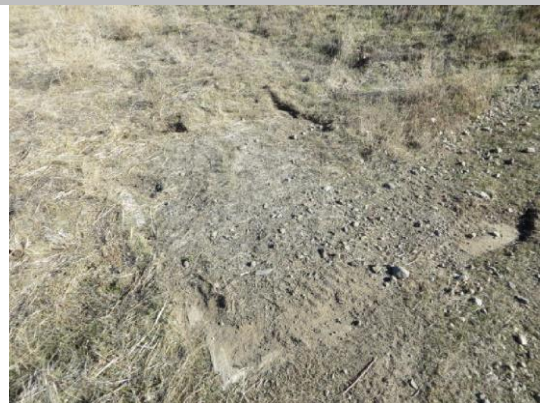
Photo 2 of 3 : UCIP\_SP\_2019\_42994\_51213.jpg

6'X8' concrete sump filled in with soil, visible at LS toe.

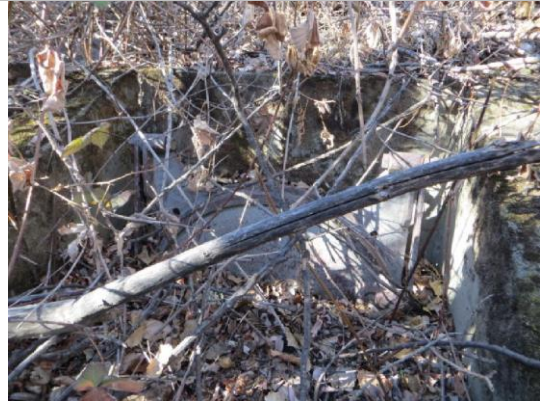
Photo 3 of 3 : UCIP\_SP\_2019\_42994\_51215.jpg

Flapgate and concrete headwall visible off WS berm.

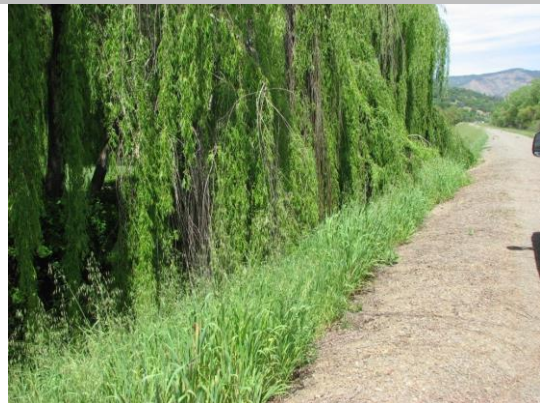
Photo 1 of 1 : SP\_2019\_NA0009\_4\_18\_20190411\_00008.jpg

View of the overgrown willow trees at the landside levee slope.

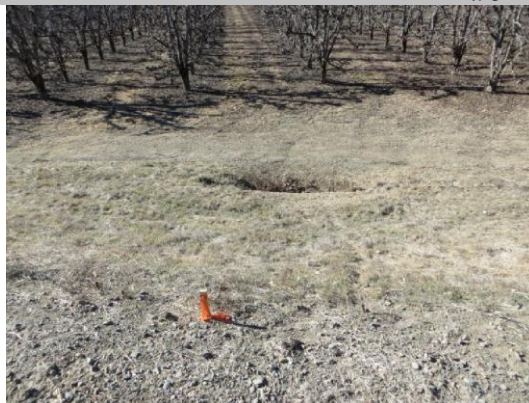
Photo 1 of 3 : UCIP\_SP\_2019\_27630\_51283.jpg

Concrete headwall and pipe visible at LS toe.

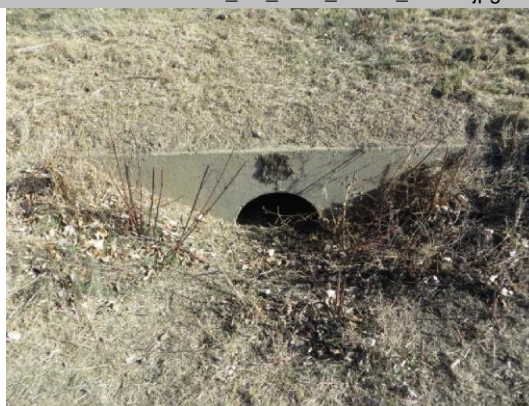
Photo 3 of 3 : UCIP\_SP\_2019\_27630\_51281.jpg

Concrete headwall and pipe visible at LS toe.

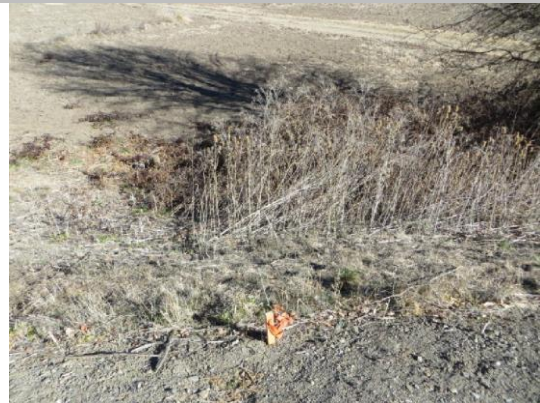
Photo 1 of 3 : UCIP\_SP\_2019\_27863\_51542.jpg

Pipe visible at LS toe covered with vegetation.

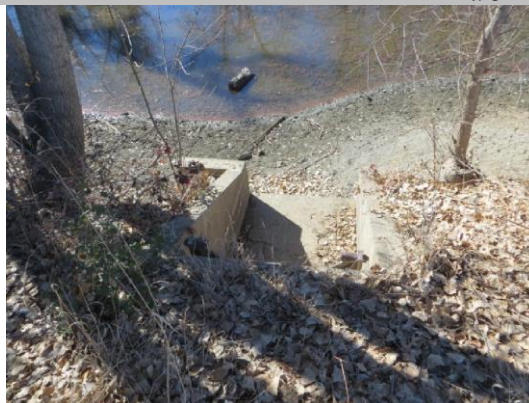
Photo 2 of 3 : UCIP\_SP\_2019\_27863\_51541.jpg

Concrete headwall and flapgate visible at WS berm.

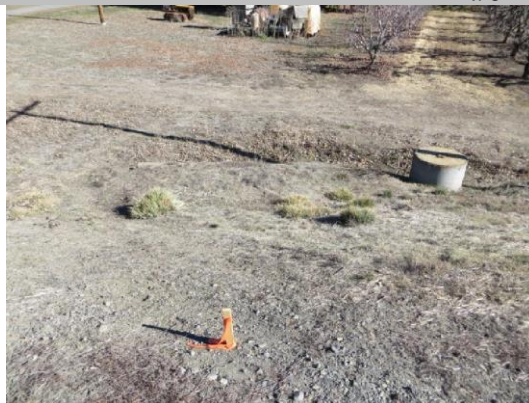
Photo 1 of 3 : UCIP\_SP\_2019\_27892\_51591.jpg

Concrete headwall visible next to concrete standpipe on LS toe.

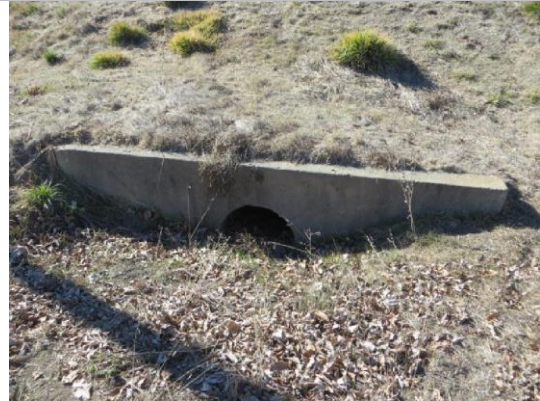
Photo 3 of 3 : UCIP\_SP\_2019\_27892\_51589.jpg

Concrete headwall visible at LS toe.

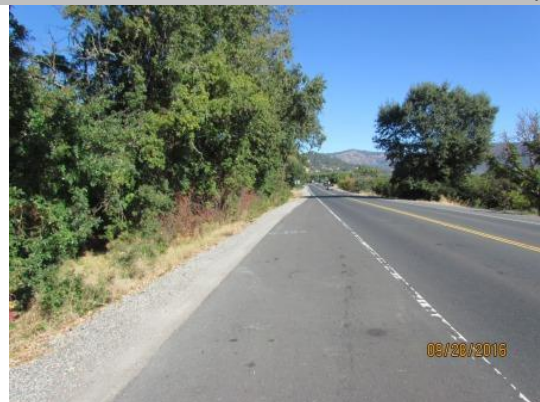
Photo 1 of 1 : SP\_2019\_NA0009\_5\_14\_20190411\_00005.jpg

View of the waterside vegetation looking upstream.

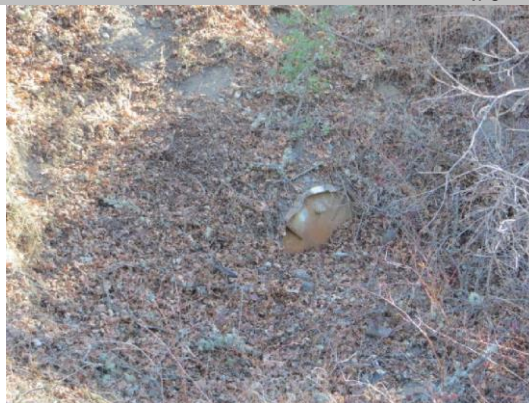
Photo 1 of 3 : UCIP\_SP\_2019\_27893\_51595.jpg

Plugged pipe visible on WS toe of roadway.

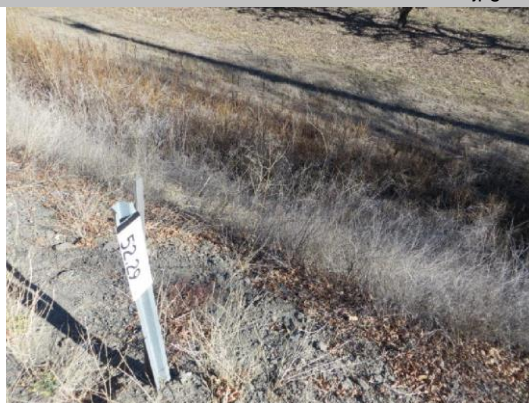
Photo 2 of 3 : UCIP\_SP\_2019\_27893\_51594.jpg

Roadway marker 52.29 on LS and WS shoulder mark pipe location on crown.

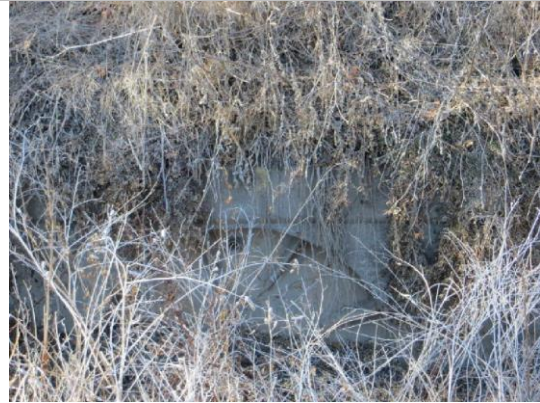
Photo 3 of 3 : UCIP\_SP\_2019\_27893\_51596.jpg

Concrete headwall and plugged pipe visible onLS toe of roadway.

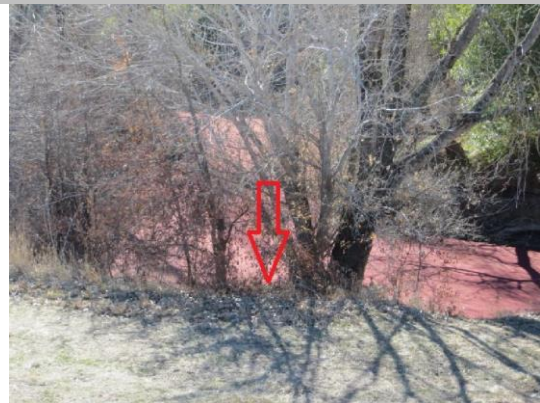
Photo 1 of 3 : UCIP\_SP\_2019\_27894\_51599.jpg

Flapgate and headwall off WS toe.

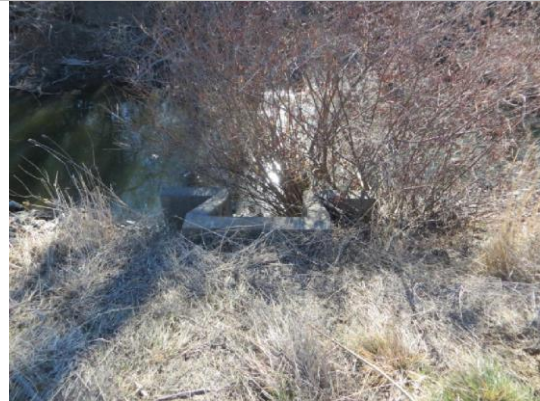
Photo 1 of 3 : UCIP\_SP\_2019\_27943\_51642.jpg

Concrete Headwall on WS berm.

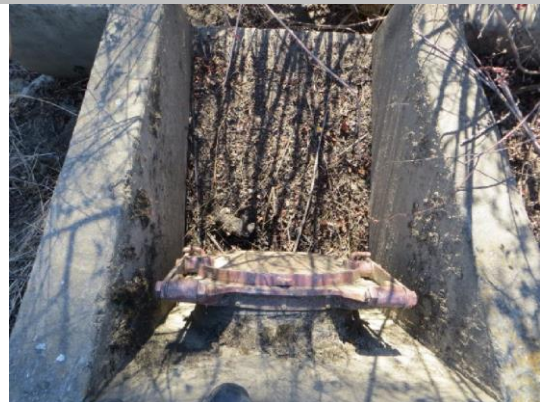
Photo 2 of 3 : UCIP\_SP\_2019\_27943\_51641.jpg

Headwall and flapgate on WS berm.

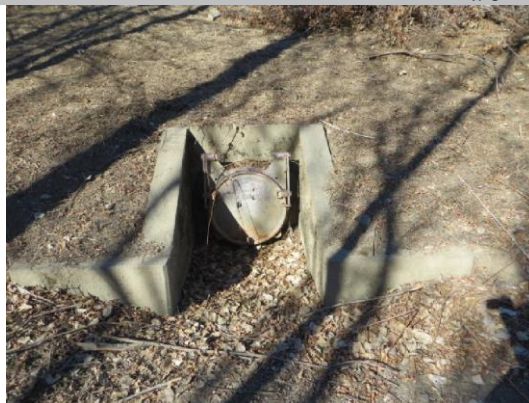
Photo 2 of 3 : UCIP\_SP\_2019\_27944\_51645.jpg

Flapgate and headwall visible on WS toe.

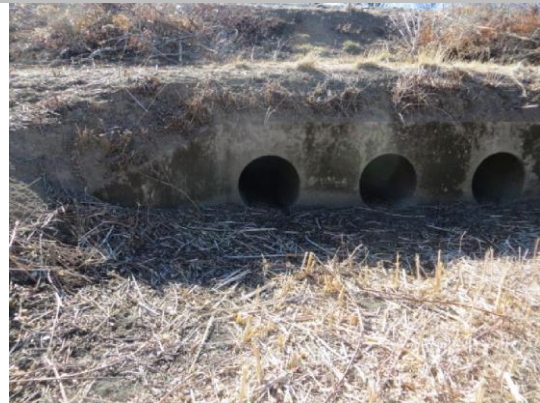
Photo 1 of 3 : UCIP\_SP\_2019\_27963\_51662.jpg

Concrete headwall on LS toe.

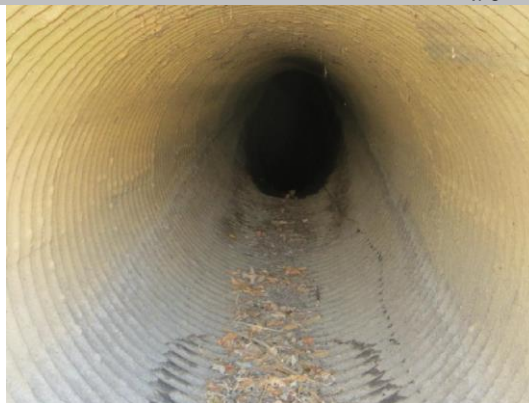
Photo 2 of 3 : UCIP\_SP\_2019\_27963\_51661.jpg

Pipe on LS toe.

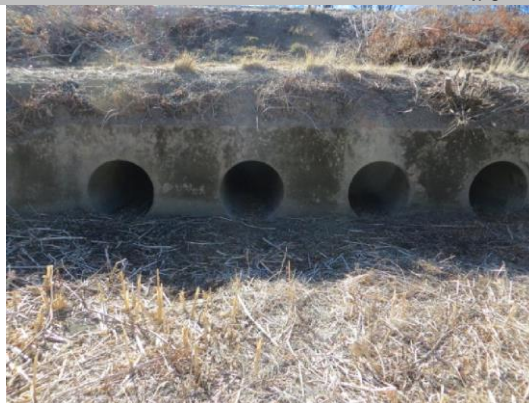
Photo 1 of 3 : UCIP\_SP\_2019\_27964\_51665.jpg

Pipe and headwall on LS toe.

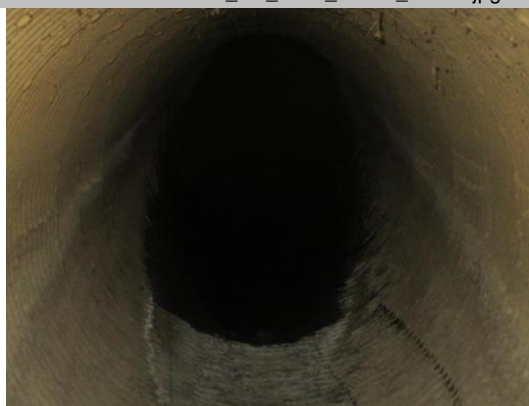
Photo 2 of 3 : UCIP\_SP\_2019\_27965\_51667.jpg

Pipe from LS toe.

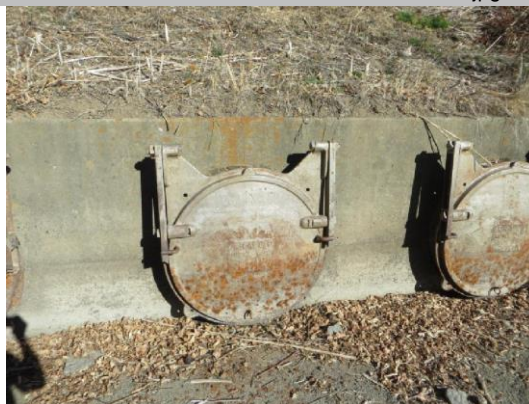
Photo 3 of 3 : UCIP\_SP\_2019\_27965\_51666.jpg

Flapgate on headwall at WS toe.

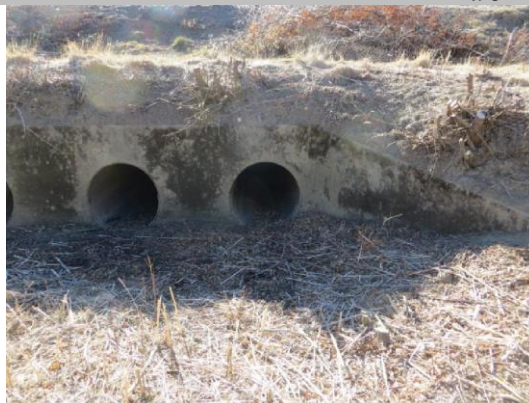
Photo 1 of 3 : UCIP\_SP\_2019\_27967\_51671.jpg

Pipe and concrete headwall on LS toe.

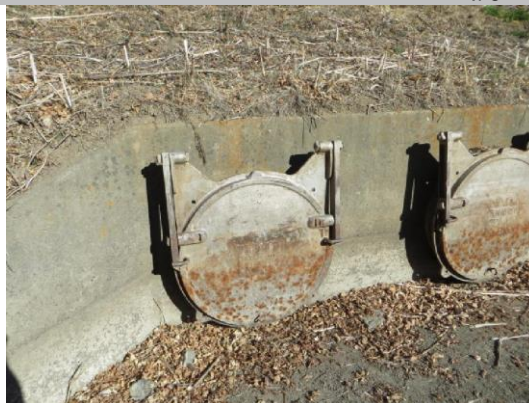
Photo 3 of 3 : UCIP\_SP\_2019\_27967\_51669.jpg

Flapgate on concrete headwall on WS toe.

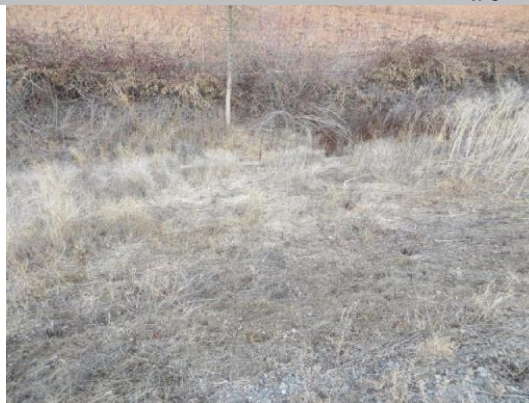
Photo 1 of 3 : UCIP\_SP\_2019\_26947\_49793.jpg

Concrete headwall visible on LS toe.

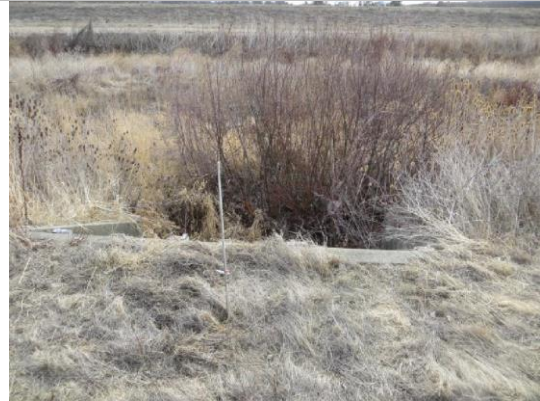
Photo 3 of 3 : UCIP\_SP\_2019\_26947\_49791.jpg

Concrete headwall visible on WS berm.

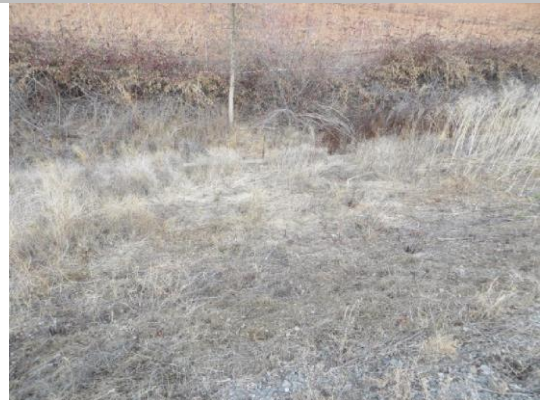
Photo 1 of 3 : UCIP\_SP\_2019\_26948\_49797.jpg

Concrete headwall and inlet visible on LS toe.

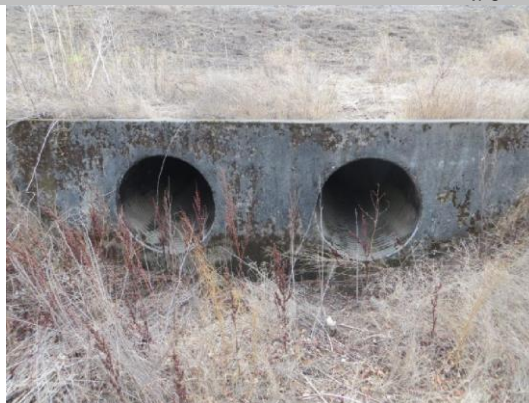
Photo 2 of 3 : UCIP\_SP\_2019\_26948\_49796.jpg

Concrete headwall and inlet visible on LS toe.

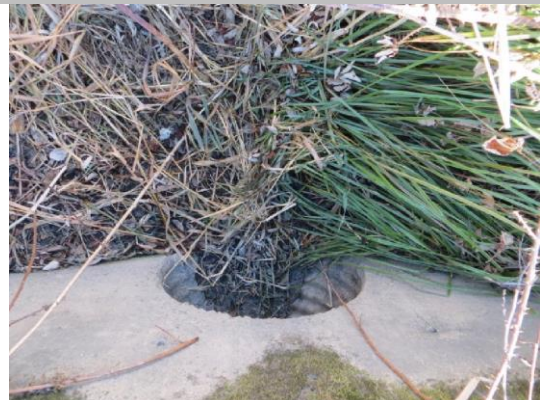
Photo 2 of 3 : UCIP\_SP\_2019\_53332\_49753.jpg

Pipe and concrete headwall visible in drainage channel on LS toe.

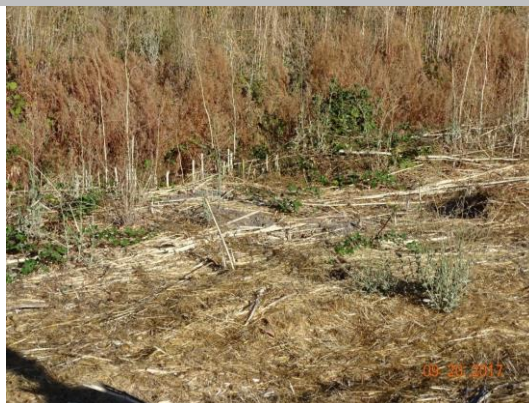
Photo 1 of 1 : SP\_2019\_NA0009\_6\_12\_20190411\_00005.jpg

View of the rodent holes along the landside slope &amp; toe. Fall 2017

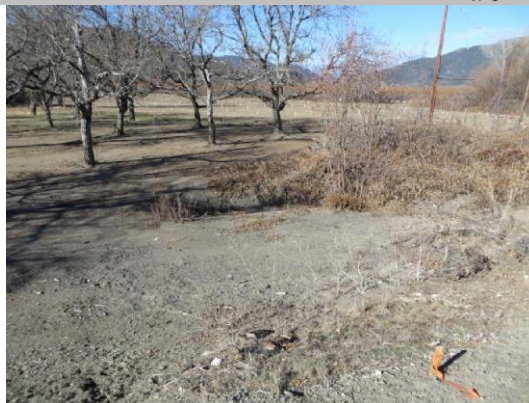
Photo 1 of 3 : UCIP\_SP\_2019\_26924\_49762.jpg

Drainpipe visible at LS toe.

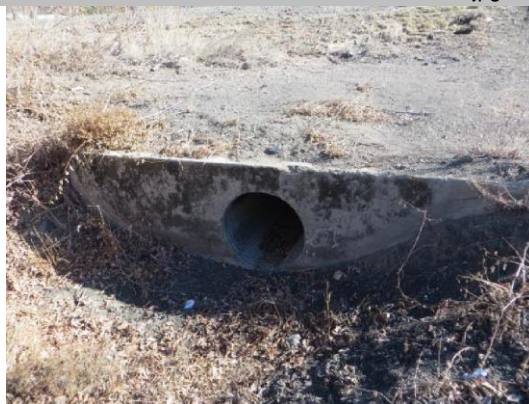
Photo 2 of 3 : UCIP\_SP\_2019\_26924\_49761.jpg

Concrete headwall and drainpipe visible at LS toe.

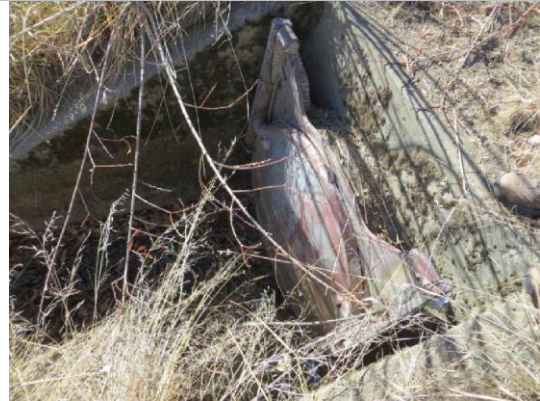
Photo 3 of 3 : UCIP\_SP\_2019\_26924\_49760.jpg

Concrete headwall visible off WS berm.

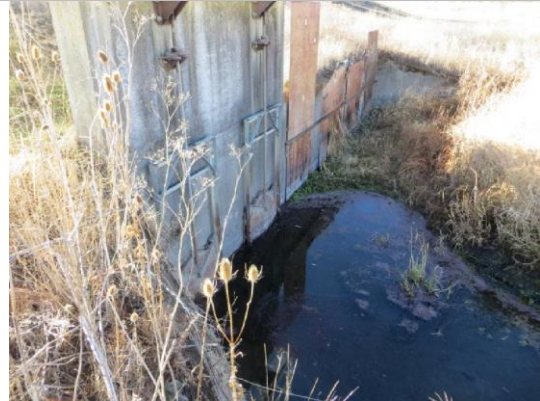
Photo 3 of 3 : UCIP\_SP\_2019\_26897\_49710.jpg

Slide gate at concrete headwall on WS toe.

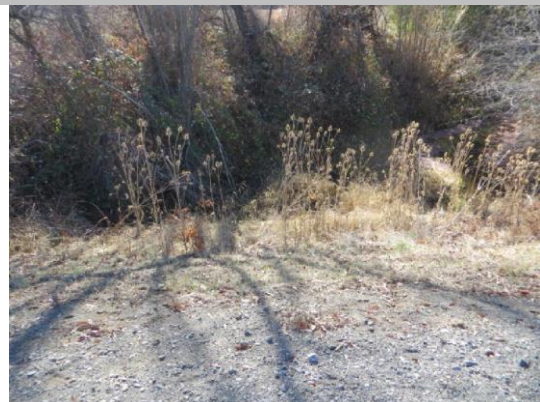
Photo 2 of 3 : UCIP\_SP\_2019\_26891\_49681.jpg

Outlet visible at concrete headwall on LS toe.

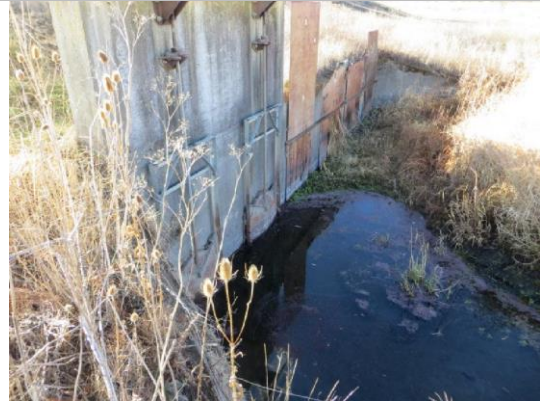
Photo 3 of 3 : UCIP\_SP\_2019\_26891\_49680.jpg

Slide gate visible at concrete headwall on WS toe.

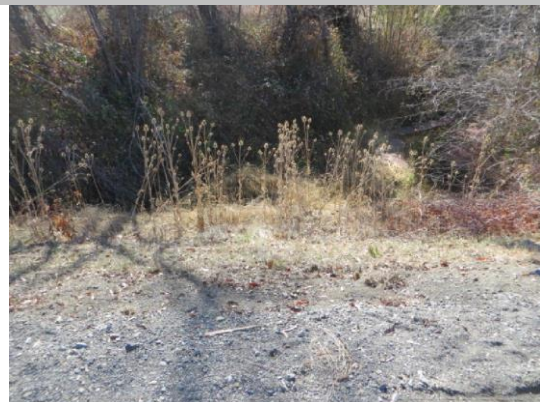
Photo 2 of 3 : UCIP\_SP\_2019\_26888\_49665.jpg

Outlet visible at concrete headwall on LS toe.

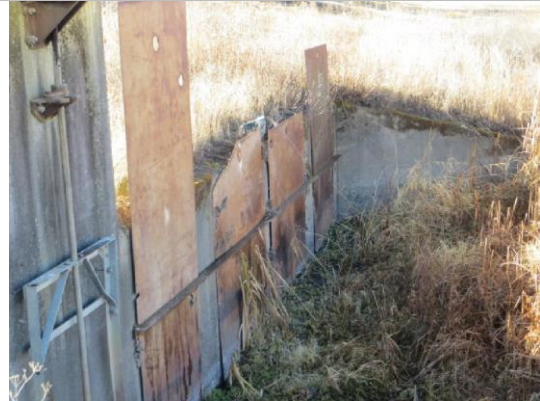
Photo 3 of 3 : UCIP\_SP\_2019\_26888\_49664.jpg

Steel slide gate visible at concrete headwall on WS toe.

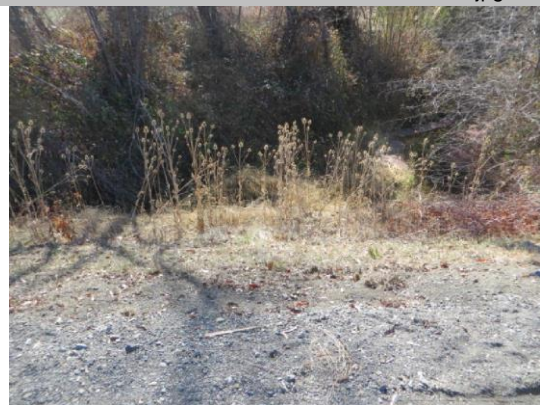
Photo 2 of 3 : UCIP\_SP\_2019\_26885\_49633.jpg

Outlet visible at concrete headwall on LS toe.

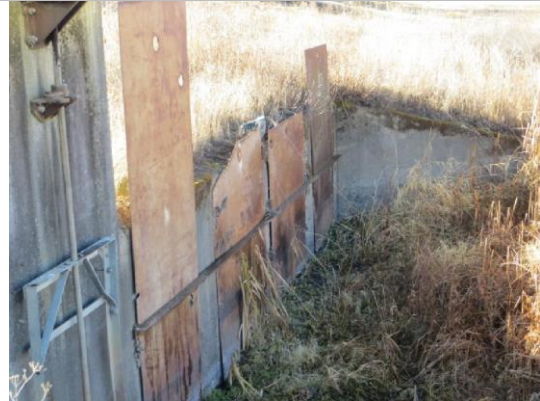
Photo 3 of 3 : UCIP\_SP\_2019\_26885\_49632.jpg

Steel plate slide gate visible at headwall on WS toe.

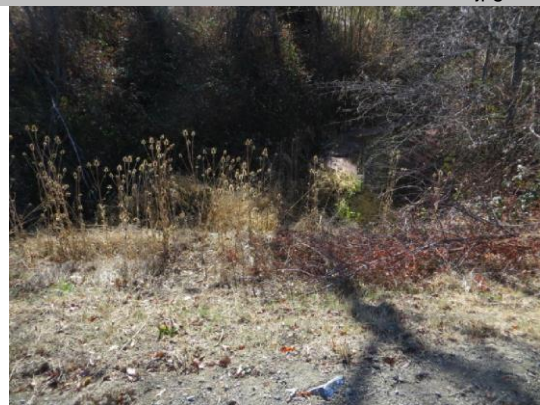
Photo 2 of 3 : UCIP\_SP\_2019\_26883\_49621.jpg

Pipe visible at concrete headwall on LS toe.

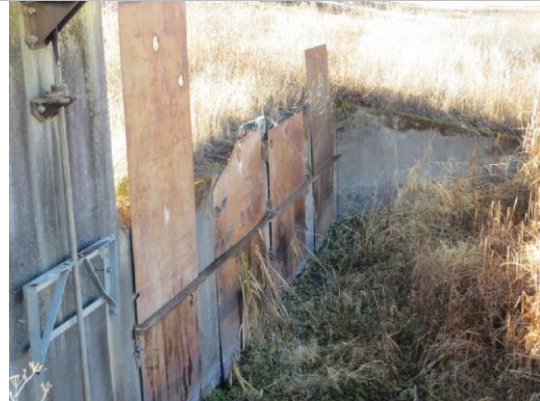
Photo 3 of 3 : UCIP\_SP\_2019\_26883\_49620.jpg

Metal slide gate visible at concrete headwall on WS toe.
